MONTHLY REPORT No 74: 1 - 30 June 2017

MONITORING THE ENVIRONMENTAL IMPACT OF THE WORKS REGARDING THE IMPROVING OF THE NAVIGATION CONDITIONS ON THE DANUBE RIVER BETWEEN CALARASI AND BRAILA, KM 375-175

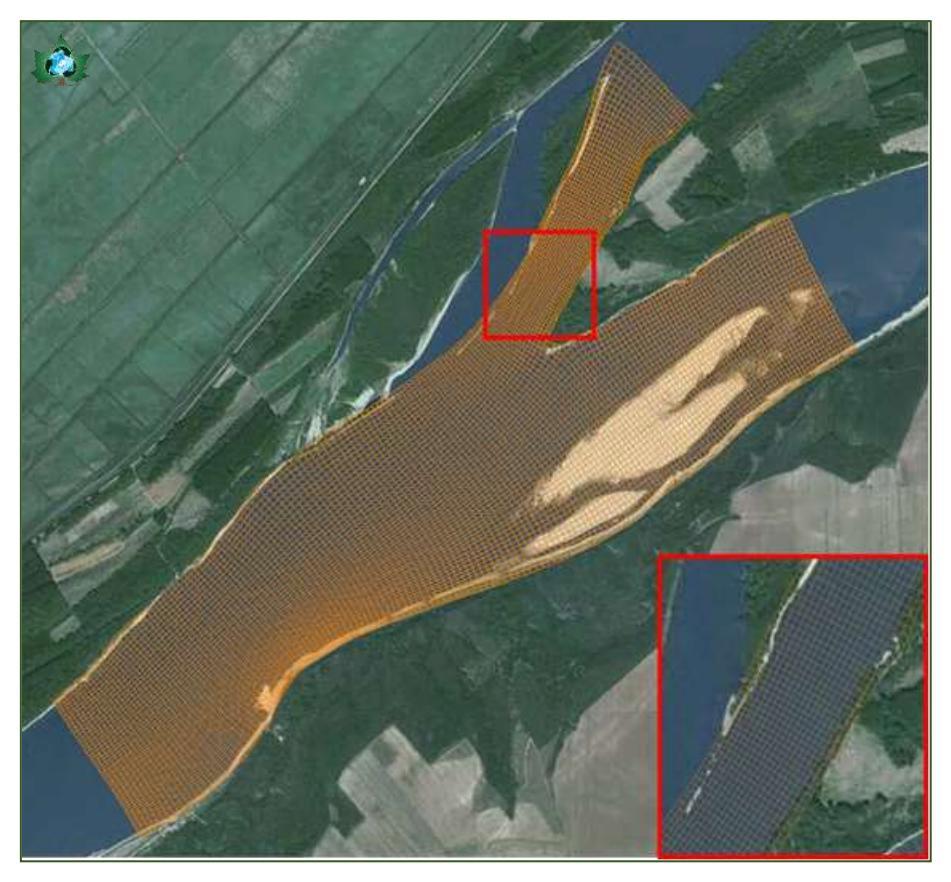
Figure 2.2.1.1 - Cells grid for studied sector

In the first phase, the study area was selected, which covers Bala - Old Danube bifurcation area (between km 348 - 344 Old Danube and km 9 Bala branch) (Figure 2.2.1.1).

A cells network was developed, covering the bifurcation area Bala branch - Old Danube (between km 348 - km 344 Old Danube and km 9 Bala branch) and meets the conditions recommended by the program, namely: orthogonality, rate for size and directions changes and (flatness, curvature) and the ratio between discretization on different directions.

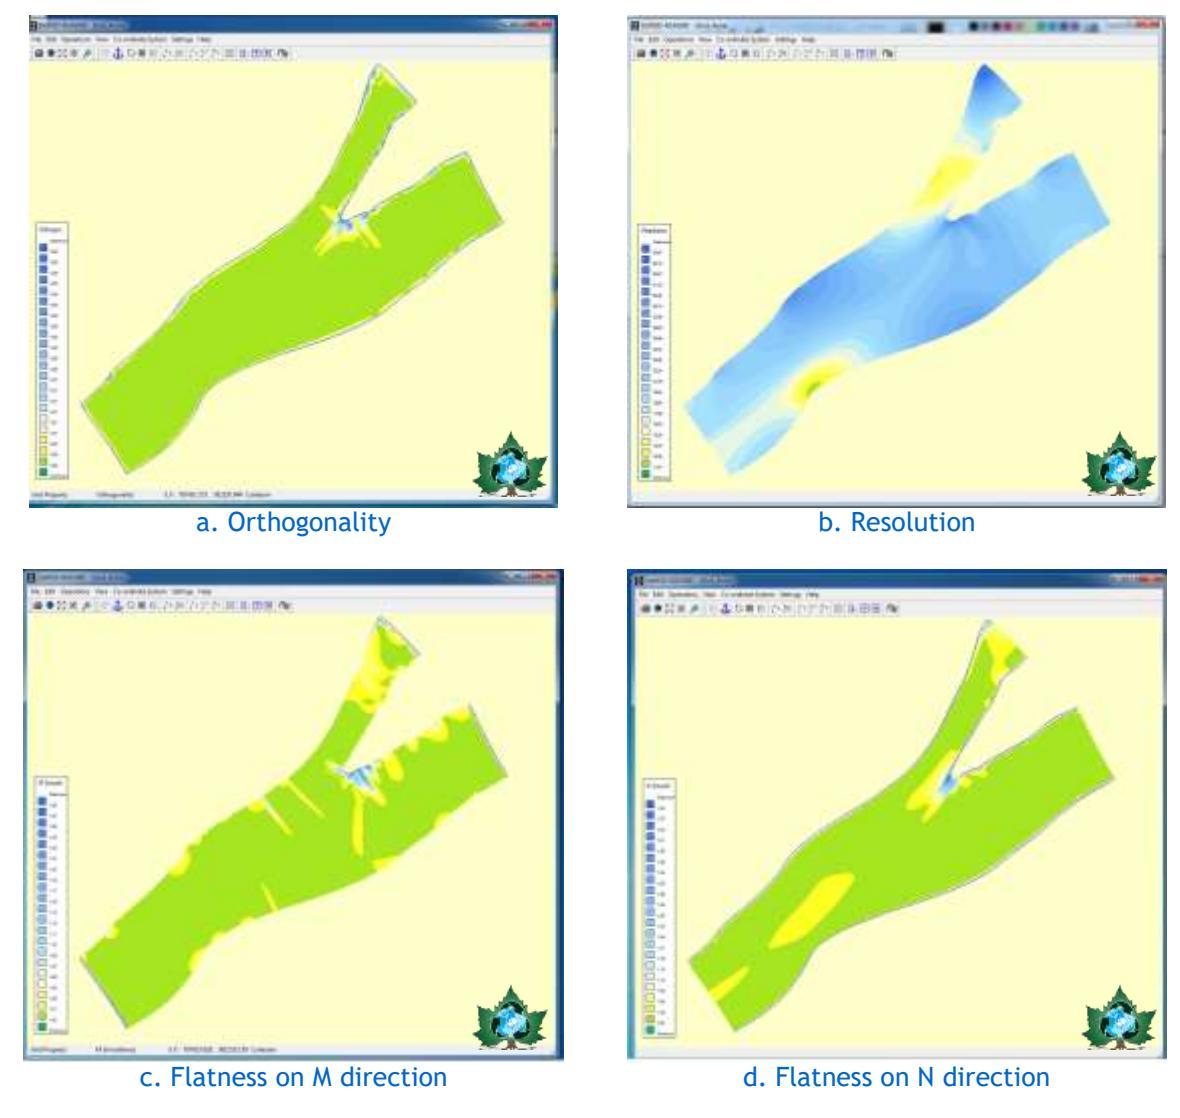
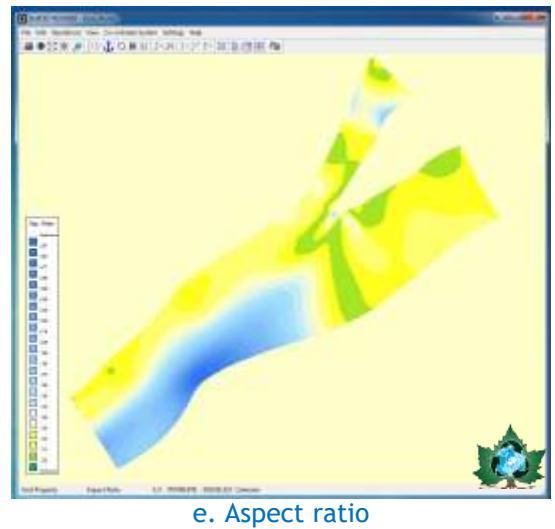
Figure 2.2.1.2 - Properties of the built cells grid

The cells grid was built using the grid module of the Delft3D software package. In order to ensure an optimal ratio between the grid discretization degree, the running time and the provided

Following the successive operations to improve the grid features, the cells grid has been optimized, in area of hydrotechnical construction on Bala branch, resulting in better property values with approx. 25% relative to the limits recommended by the numerical modeling program.

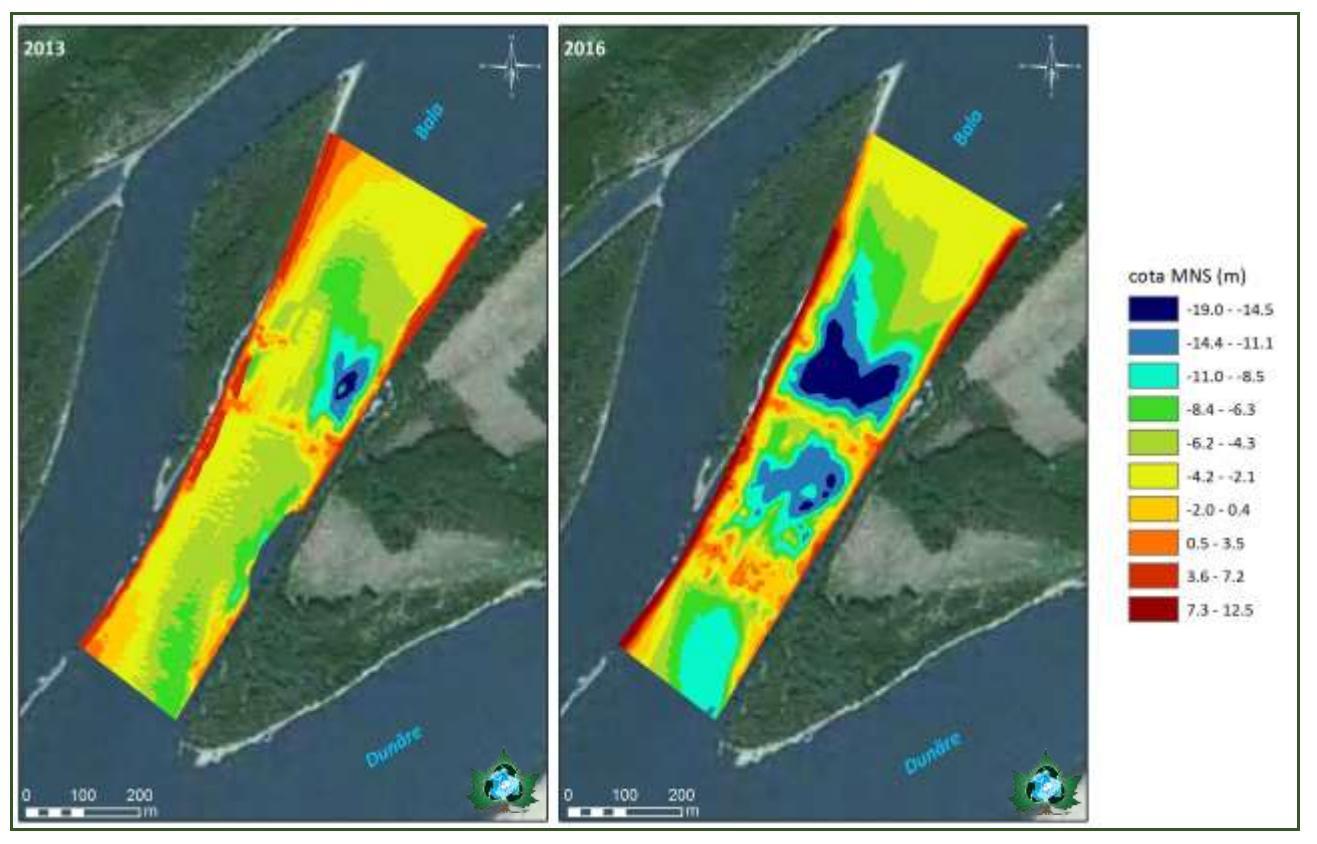
Figure 2.2.2.1 - Representation of the riverbed in Bala branch area, during pre-construction period [2013] and post-construction [2016]

To highlight the morphological changes that took place in critical point CP01 area, following the construction of the new bottom sill, based on multi-beam bathymetric measurements, in Figure 2.2.2.1 is represented the riverbed in June 2013 (pre-construction), respectively in March 2016 (post-construction). The differences recorded during this period can be observed also in the three-dimensional representation in Figure 2.2.2.2.

Longitudinal control section SLCB2 is located on Bala branch center (Figure 2.2.2.9). As presented in Figure 2.2.2.10, it can be observed that an erosion pit was formed immediately downstream of the new bottom sill. At the same time, upstream of the new construction can be observed an area with erosion of up to 5 m. Downstream of the old bottom sill, the erosion pit located during pre-construction period near the right bank it expanded. (Figures 2.2.2.1 and 2.2.2.2)

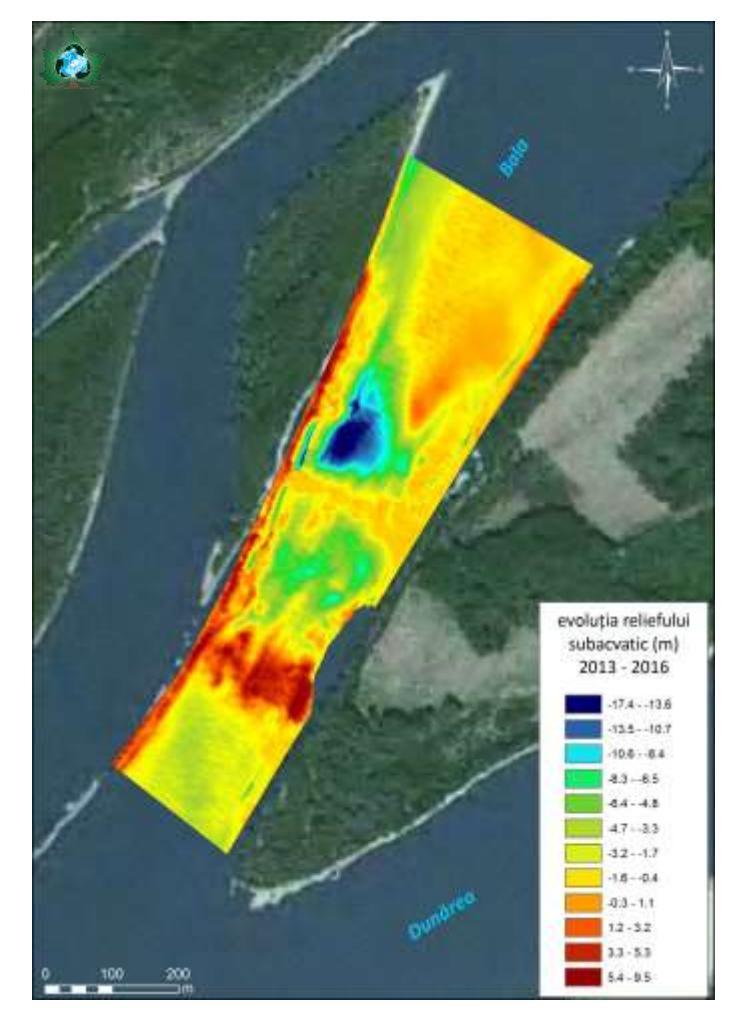
Figure 2.2.2.3 - Evolution of the underwater landscape before (2013) and after (2016) the bottom sill construction

As can be observed in the upstream area of the new bottom sill, are evident erosion up to -9.2m, value recorded at the right bank. In Figure 2.2.2.3, the new bottom sill appears as a deposits area of up to 9.5 m. The sector between the two bottom sills is characterized by erosions of up to -10.5 m.

Erosions also resulted in area of the old bottom sill, the values ranging around -5.4 m. Immediately downstream from the old bottom sill can be seen, towards the left bank, an area with erosions up to -17.4 m. Considering the fact that before the works began in June 2013, downstream from the old bottom sill, there was an erosion pit at the right bank, it can be said that in 2016, the pit has deepened and extended toward the right bank.

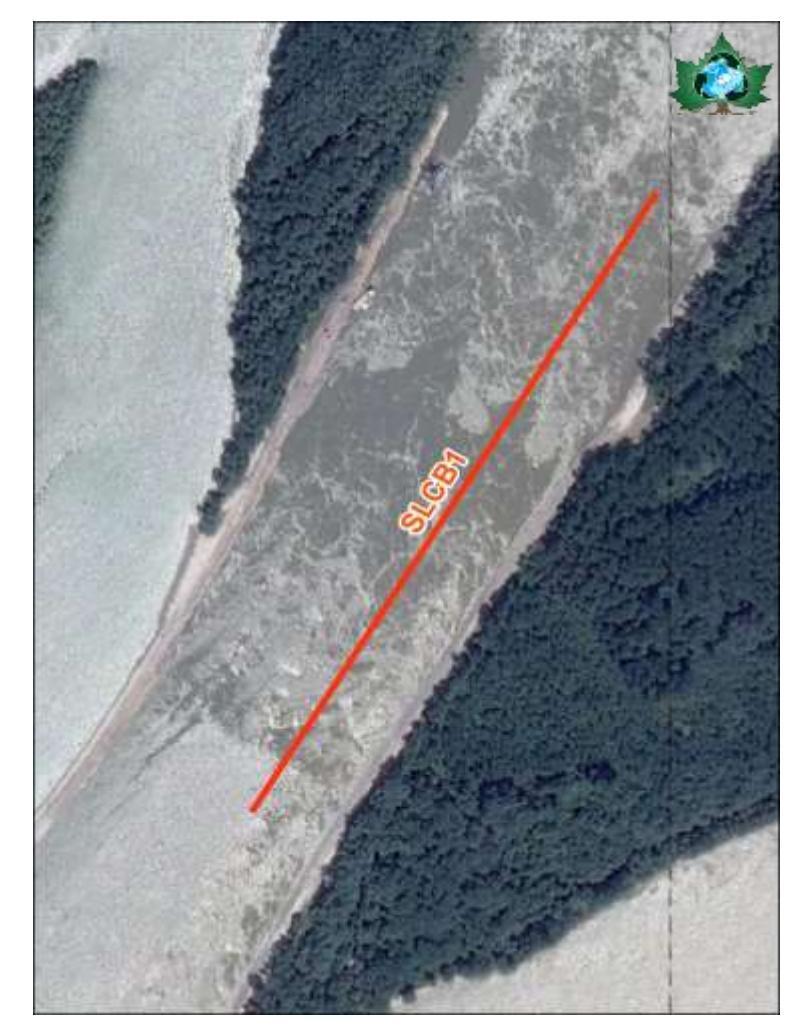
Figure 2.2.2.4 - Location of the longitudinal control section SLCB1 [right bank]

In order to perform the comparative analysis on hydromorphological and hydrodynamic conditions in CP01 area, the longitudinal control sections SLCB1, SLCB2 and SLCB3 were investigated.

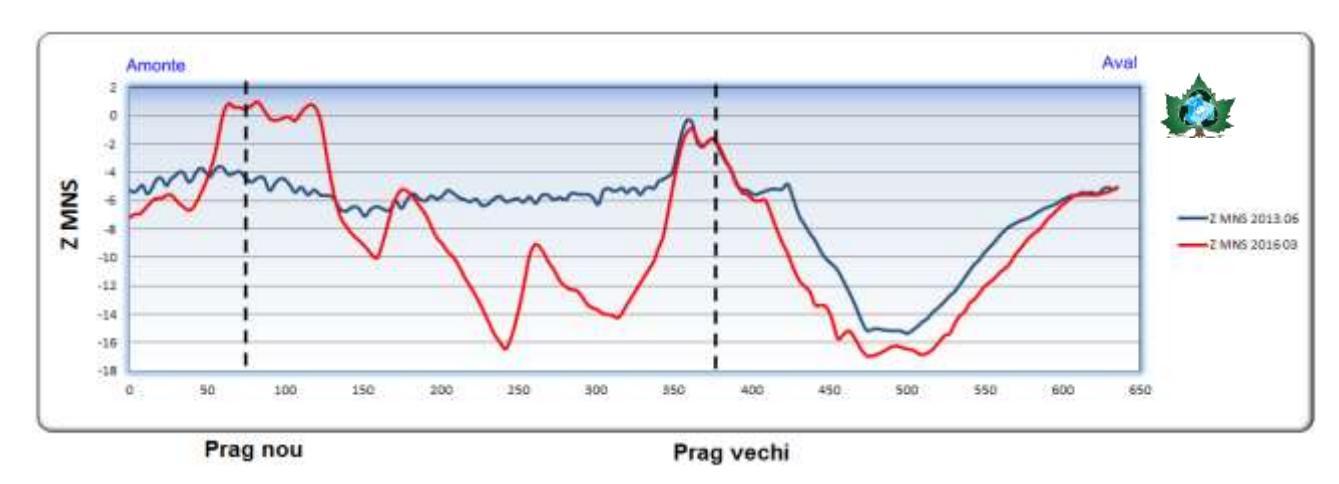
Figure 2.2.2.5 - Logitudinal section SLCB1 representing the riverbed in pre-construction and post-construction period

In Figure 2.2.2.5 are represented the riverbed geometries resulting from the bathymetric measurements of June 2013 and March 2016, in SLCB1 longitudinal control section, located at the right bank (Figure 2.2.2.4). In this section it can be seen that in 2016 (post-construction) were formed erosion areas upstream and downstream from the new bottom sill. Also, the erosion pit formed downstream from the old bottom sill, deepened compared to the period before the hydrotechnical works started.

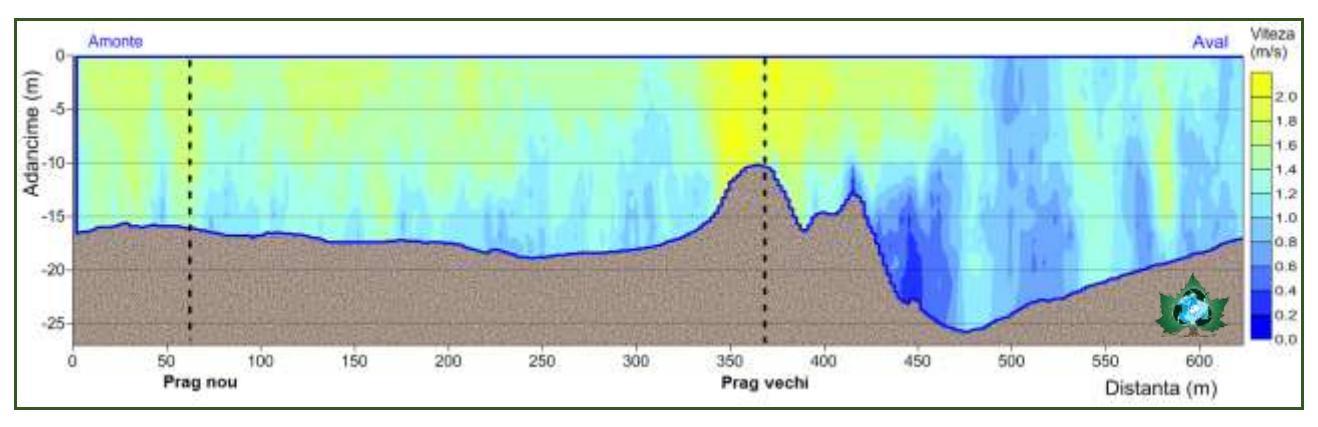
Regarding the velocity of water stream, on the longitudinal control section SLCB1, in preconstruction period are observed maximum values of approx. 2.0 m/s, recorded near the old bottom sill (Figure 2.2.2.6).

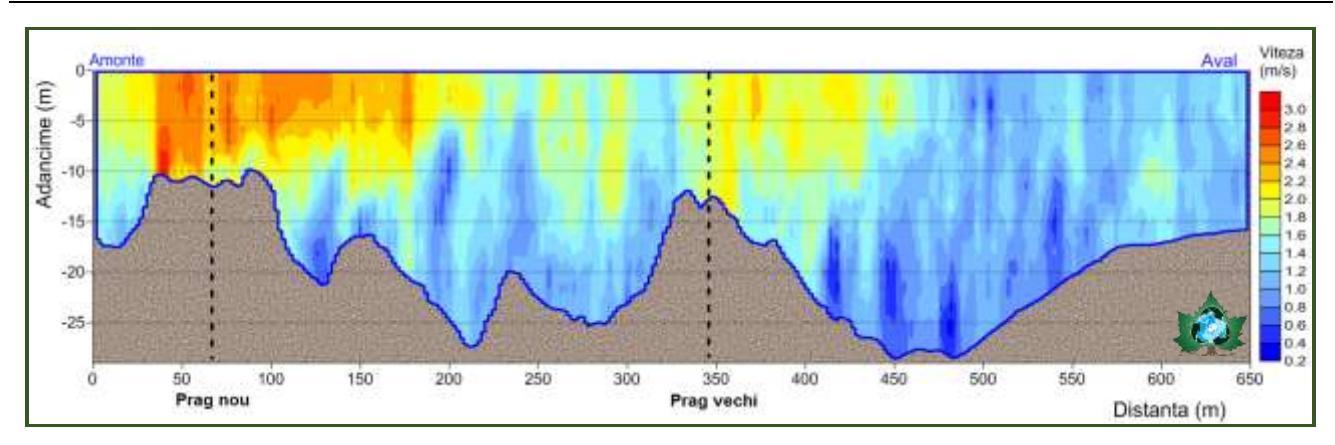
Figure 2.2.2.7 - Longitudinal section SLCB1 with water current velocity distribution post-construction period [2016]

Following the analysis of the water flow velocity distribution in SLCB1, during the postconstruction period, maximum values of over 3 m/s were recorded near the new bottom sill (Figure 2.2.2.7).

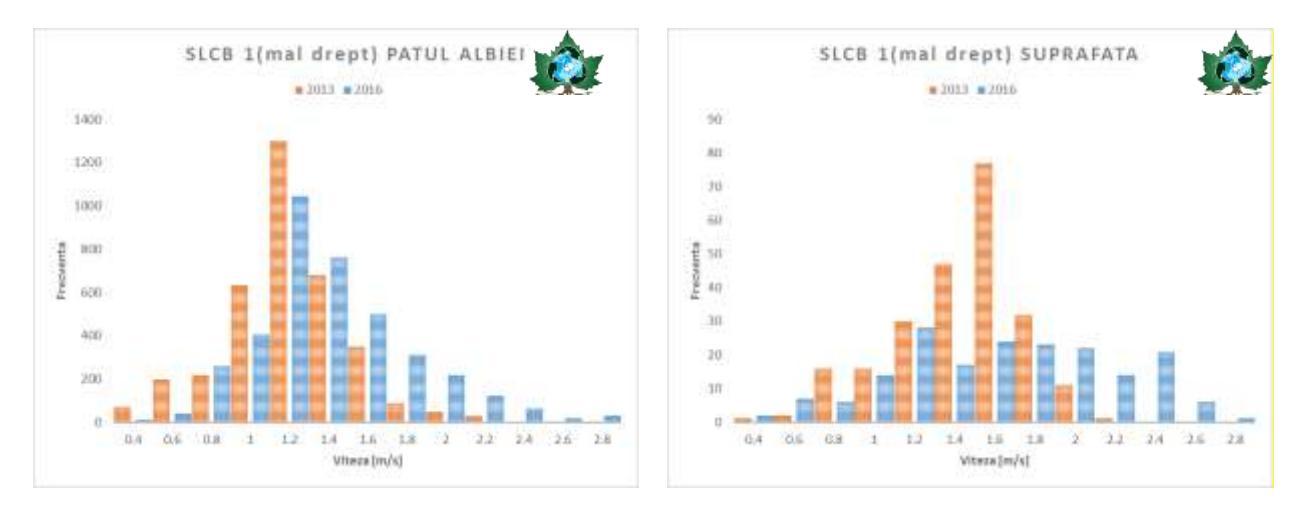
Figure 2.2.2.8 - Velocity histogram - comparative analysis on longitudinal control section SLCB1, preconstruction period [2013] and post-construction [2016]

In order to perform the comparative analysis, based on the results obtained from the field measurements, velocity histograms were made in which were exposed the values from preconstruction (2013) and post-construction (2016) - periods with comparable flows.

In the case of SLCB 1, according to velocity histogram represented in Figure 2.2.2.8, it can be observed that for both the riverbed layer and the water surface layer, the histogram shape differs between the two periods. Thus, for 2016 the recorded velocity range increased from maximum values of 2.2 m/s for 2013, up to velocities of 2.8 m/s for both the riverbed area and the water upper layer.
